Evaluation of coastal response to Hurricane Ike through pre-storm and post-storm aerial photography

Richard L. Watson, Ph.D., P.G.

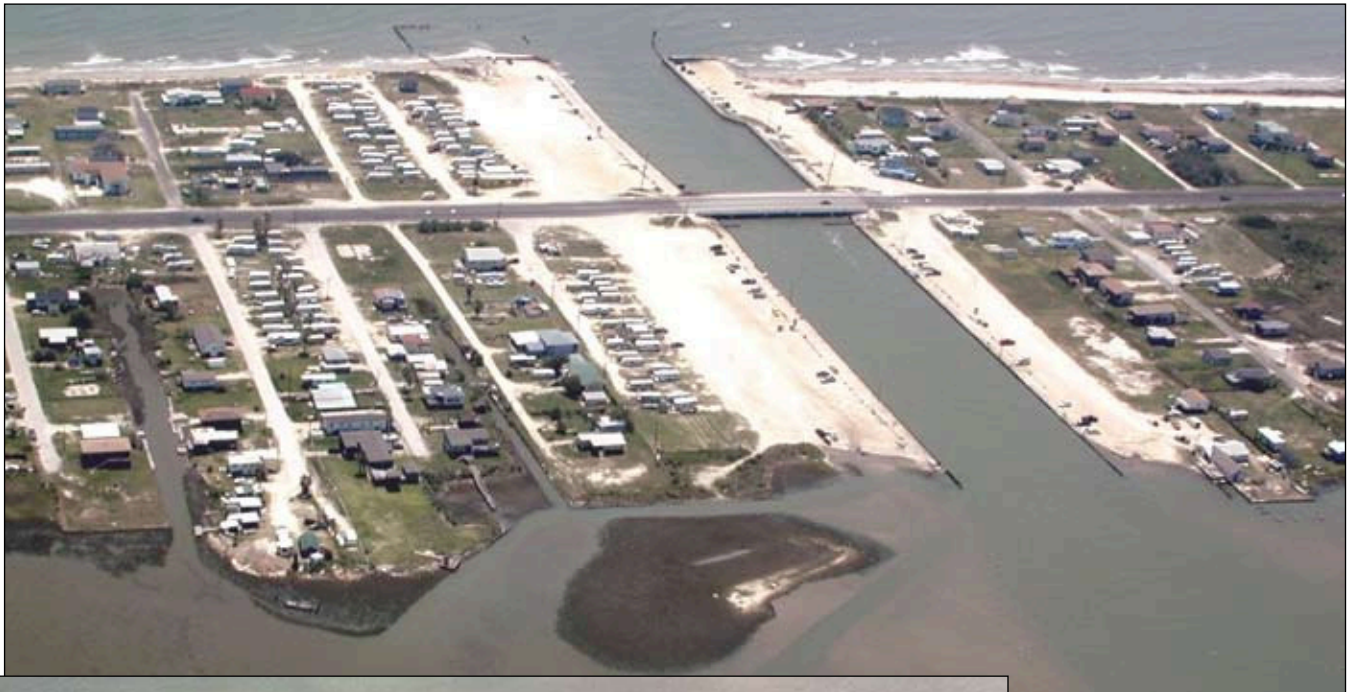
ft and, probably, the strongest onshore winds. Figures 5 and 6 show Rollover Pass with the town of Gilchrist on the left and Caplen on the right before and after Ike. The inundation and overwash destruction was nearly complete, with only a few homes partially remaining. Only one house remains seaward of the road, and it was severely damaged (Figure 7). Remnants of geotextile tubes can be seen along the beach in the post-storm photographs. They gave no protection against Ike.

Figure 5. Rollover Pass, with the towns of Gilchrist on the left and Caplen on the right before Hurricane Ike. Photograph taken by the author, 16 June 2006.

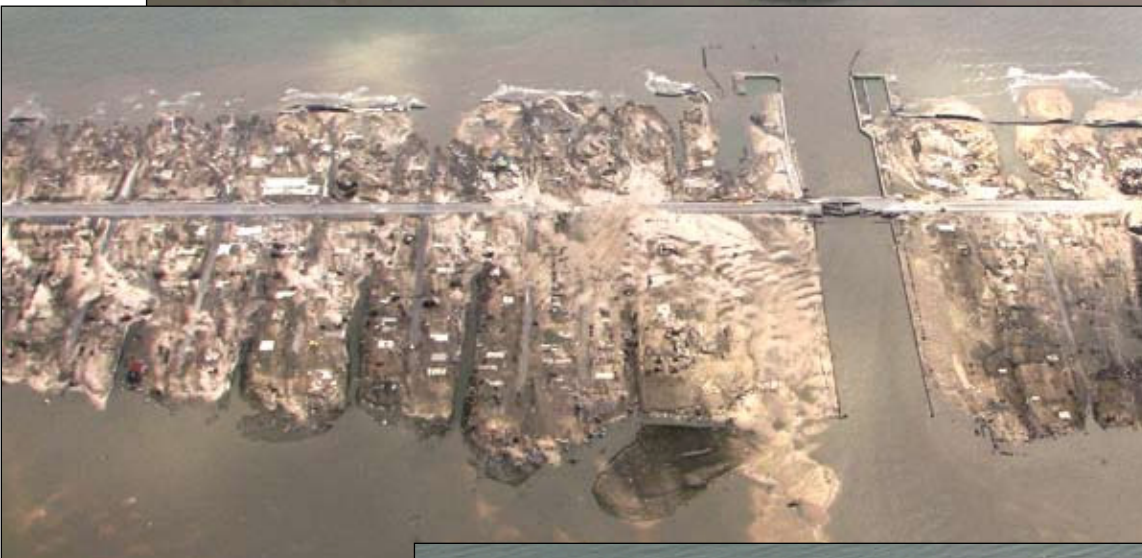
The construction of Rollover Pass in the late 1950s has caused an annual loss of more than 200,000 cu yd of beach sand into Rollover Bay and the adjacent Gulf Intracoastal Waterway (GIWW) (Bales and Holley 1984, 1985, 1989; Watson 1999). Erosion on the Bolivar Peninsula in the vicinity of Caplen and Gilchrist would likely have been much less if 10–14 million cu yd of beach sand had not been lost through Rollover Pass and into the bay and GIWW since the pass was opened. Bayward sand transport is one of the main causes of severe ongoing beach erosion at Gilchrist and Caplen adjacent to Rollover Pass and has left the upper portion of the Bolivar Peninsula with few remaining sand resources (Watson 1999). This has left the upper Bolivar Peninsula poor in sand, with only a thin veneer of sand overlying outcropping marsh deposits (Watson 1999 and personal observations by the author, February 2009).

Figure 6. Rollover Pass, Gilcrest, and Caplen 15 September 2008, two days after Hurricane Ike. The towns are completely destroyed. Photograph by the author.

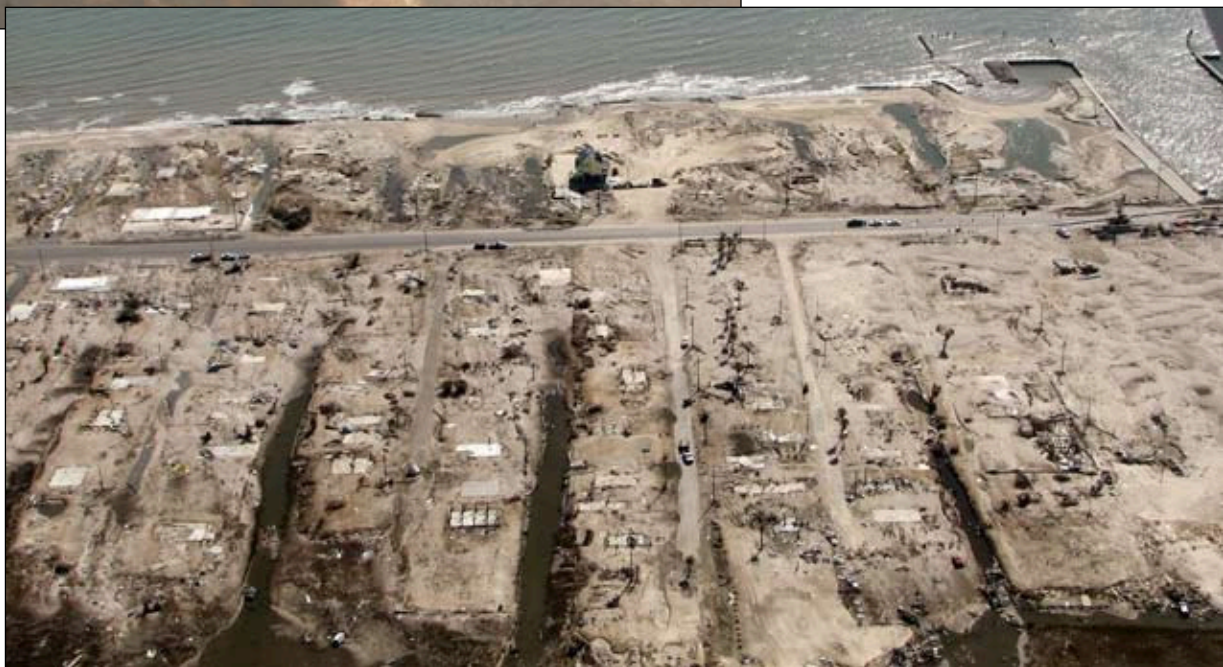
Figure 7. Only one house in Gilchrist in the upper center of the photograph remains standing post-Ike. Photograph by the author, taken 28 October 2008.

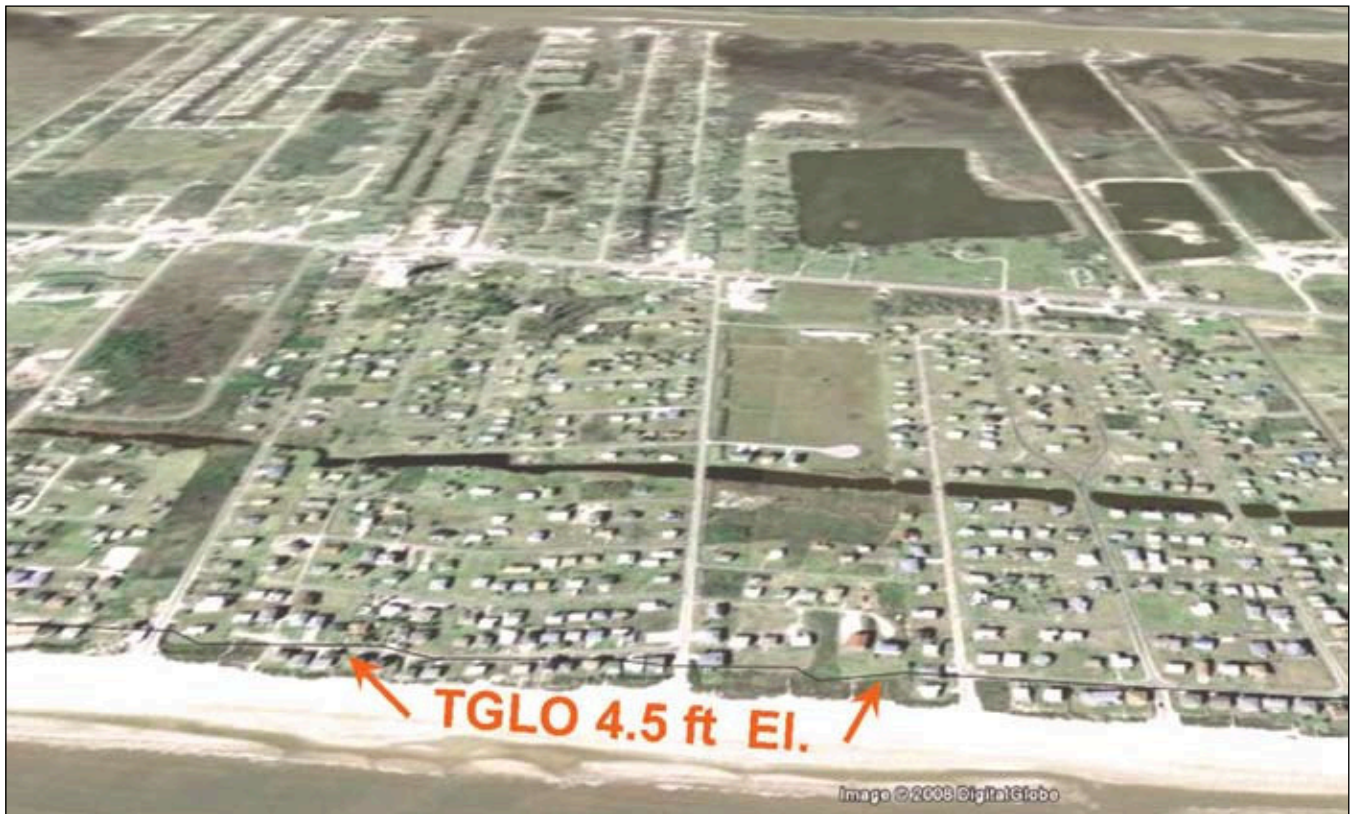
Crystal Beach, a much larger town than Gilchrist or Caplen, was severely overwashed with most of the homes in the first nine or 10 rows of homes destroyed (Figures 8 and 9). Like Gilchrist and Caplen, Crystal Beach had little in the way of dune protection.

Figure 8. Crystal Beach, from Google Earth before Hurricane Ike. The Texas General Land Office (TGLO) 4.5 ft line is the estimated new vegetation line. Structures seaward of that line cannot be rebuilt.

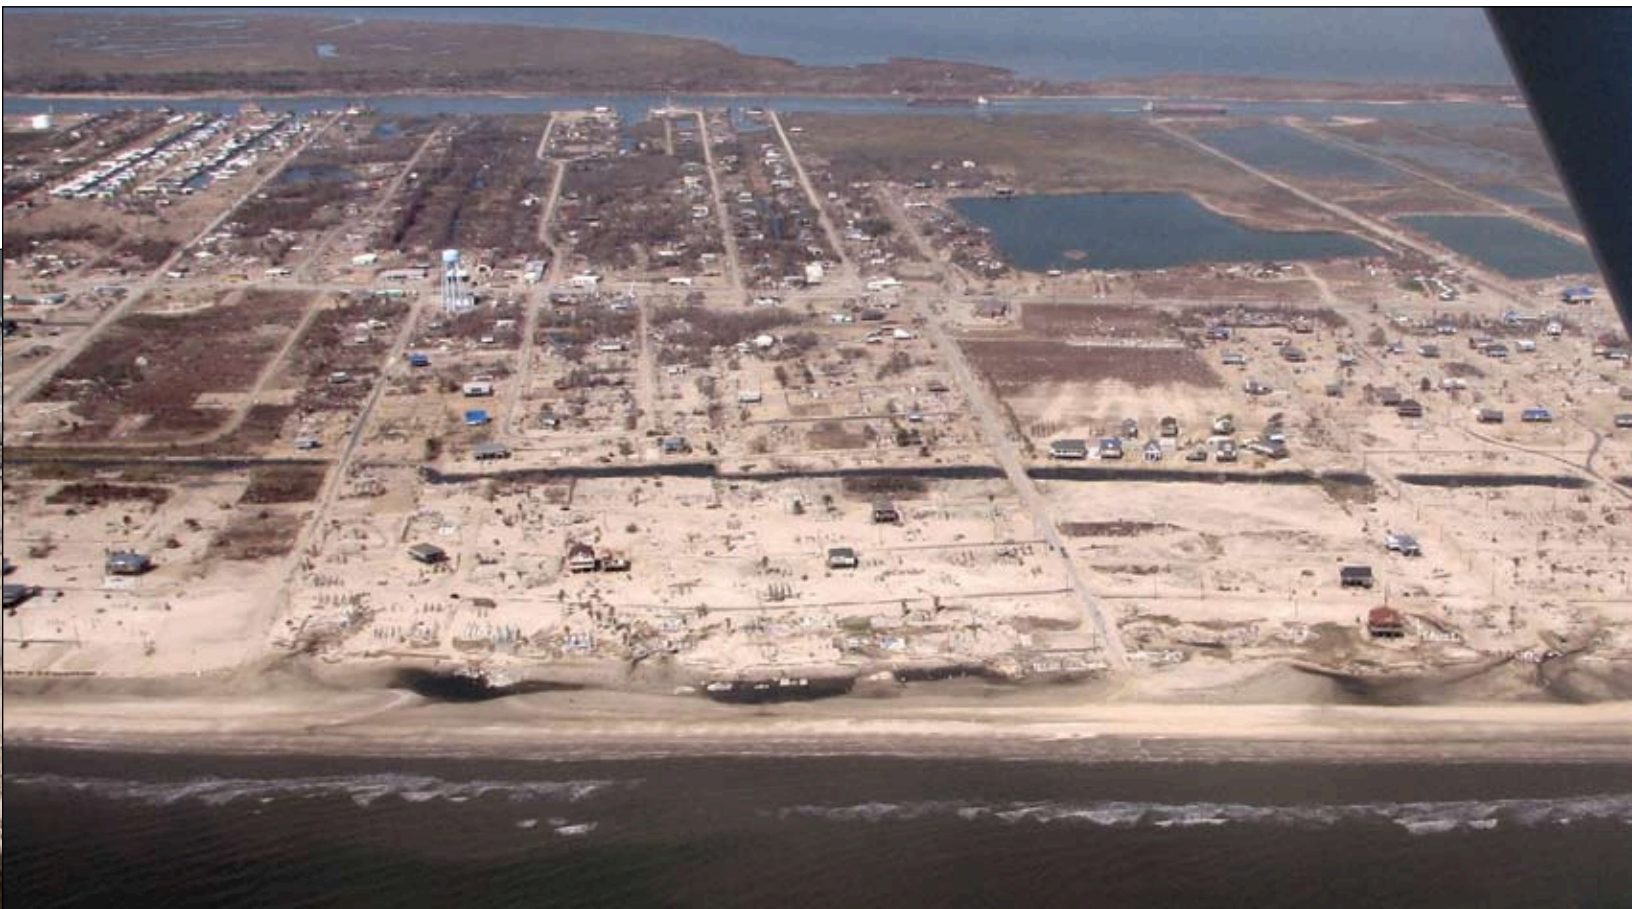
Figure 9. Crystal Beach after Hurricane Ike. Many blocks of homes have been completely destroyed. Photograph by the author taken 28 October 2008.

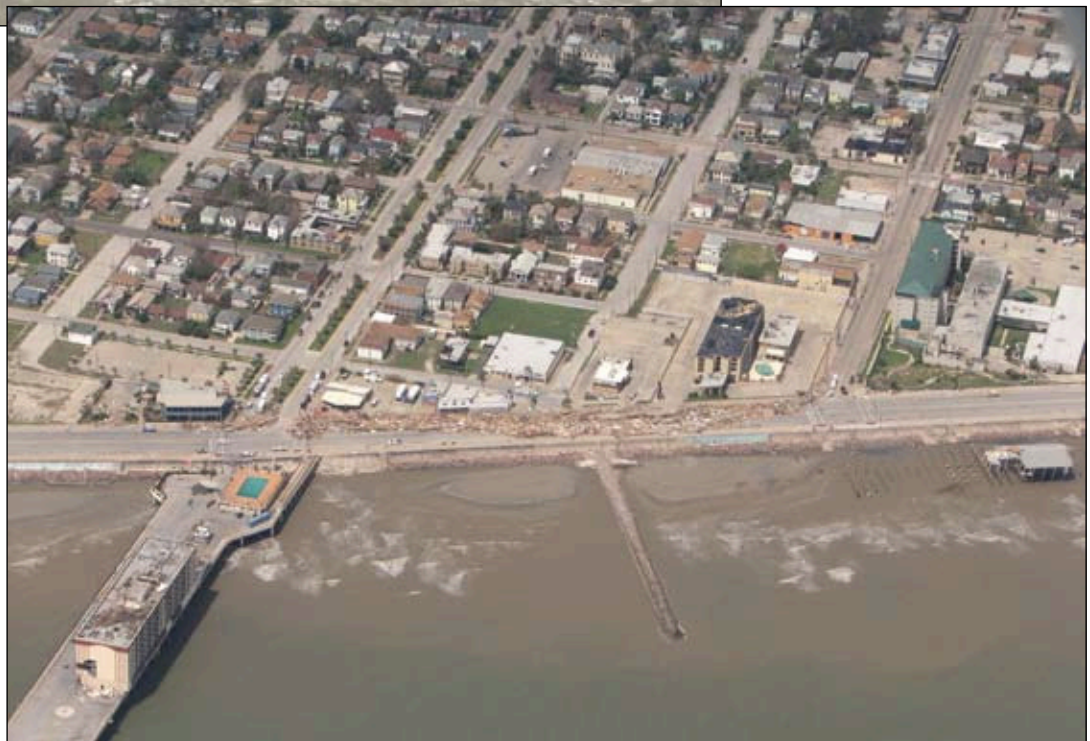
Most of the city of Galveston has been protected from overwash by a substantial, long, and high seawall. It was constructed in response to the extreme damage by the 1900 hurricane that nearly completely destroyed the then-important port city. In addition, much of the land behind the seawall was raised with dredged material. The seawall protected the city behind it from frontal overwash by Ike, but much of the protected area was flooded from behind, causing severe damage, though much less than by the full force of frontal overwash. On an overflight only two days after Ike, we were surprised to see the streets were clear and there seemed to be little damage, except for debris along only two blocks of the seawall (Figure 12). This debris is all that remains of the famous Balinese Room, a night club which was built out in the Gulf on pilings seaward of the seawall.

Figure 12. Remains of the Balinese Room (center of photograph) on top of the seawall. Note that the streets are clear and most of the structures behind the seawall are relatively undamaged. Photograph by the author, taken two days after Ike on 15 September 2008.

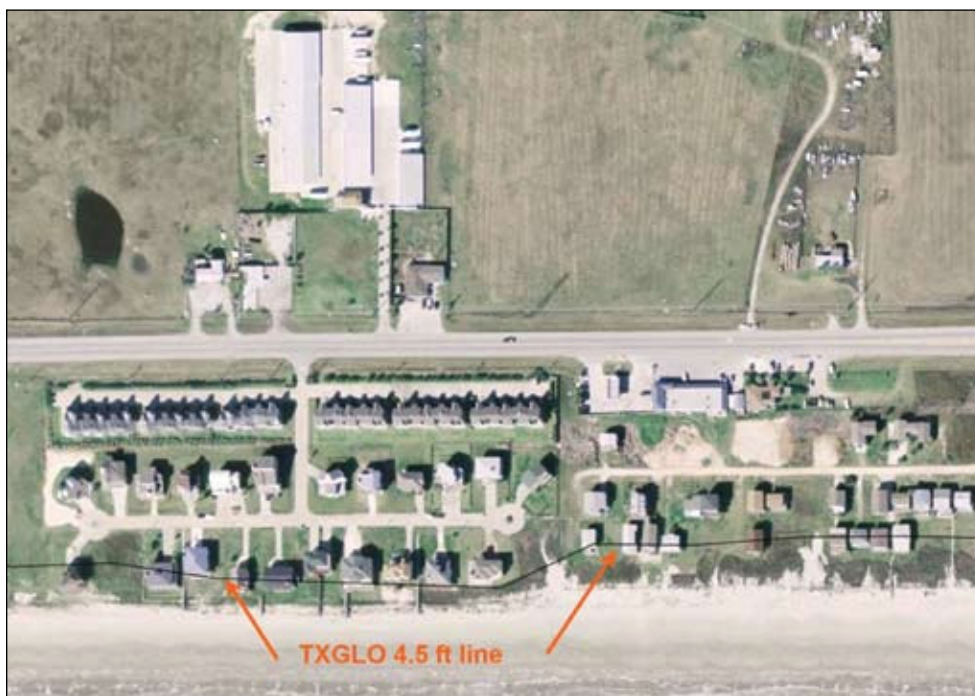
On Galveston Island, west of the area protected by the seawall, there was beach and dune erosion, and damage to houses along the beach (Figures 13 and 14). Two days after storm passage, some of these houses were still standing in the edge of the water. Several of the houses on the right of Figure 13 were destroyed. There was little dune protection along Galveston

Figure 13. West Galveston before Ike, from Google Earth.
The TGLO 4.5 ft line is the estimated new vegetation line.

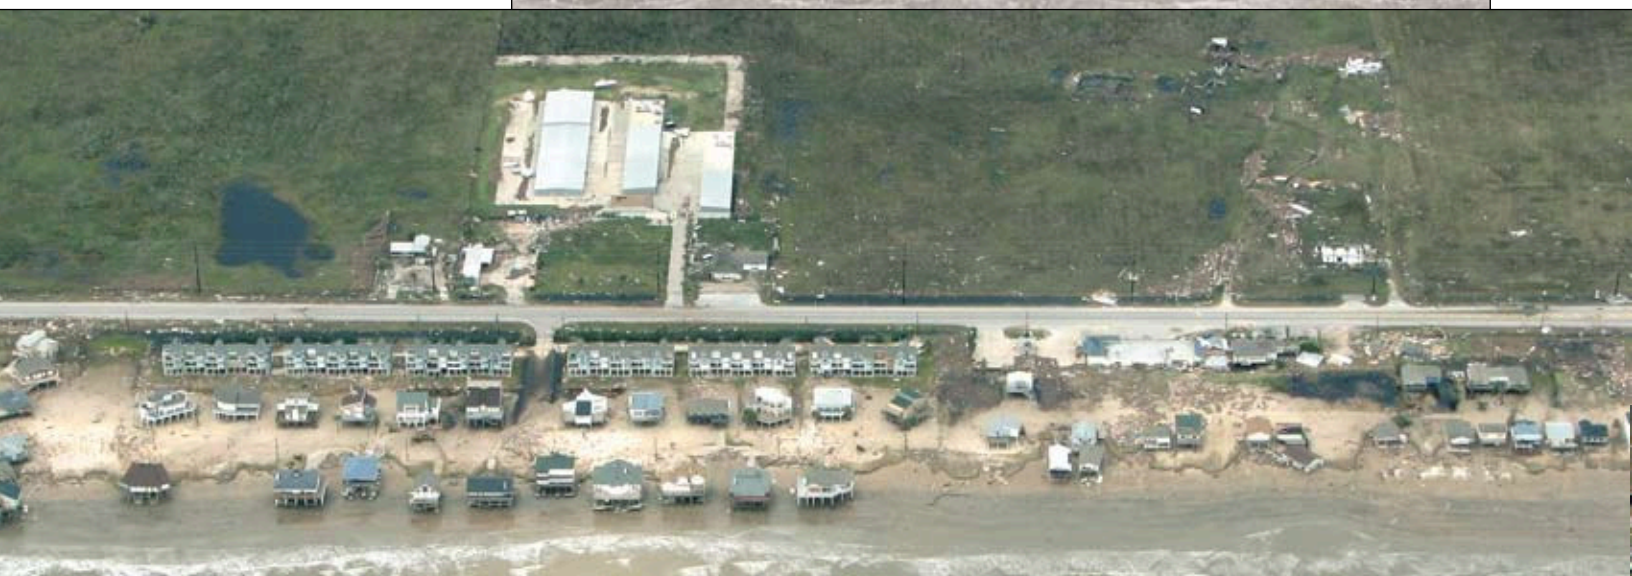
Figure 14. West Galveston Island two days after Ike.
Some homes have been destroyed and others are still standing in the water. Photograph by the author taken 15 September 2008.

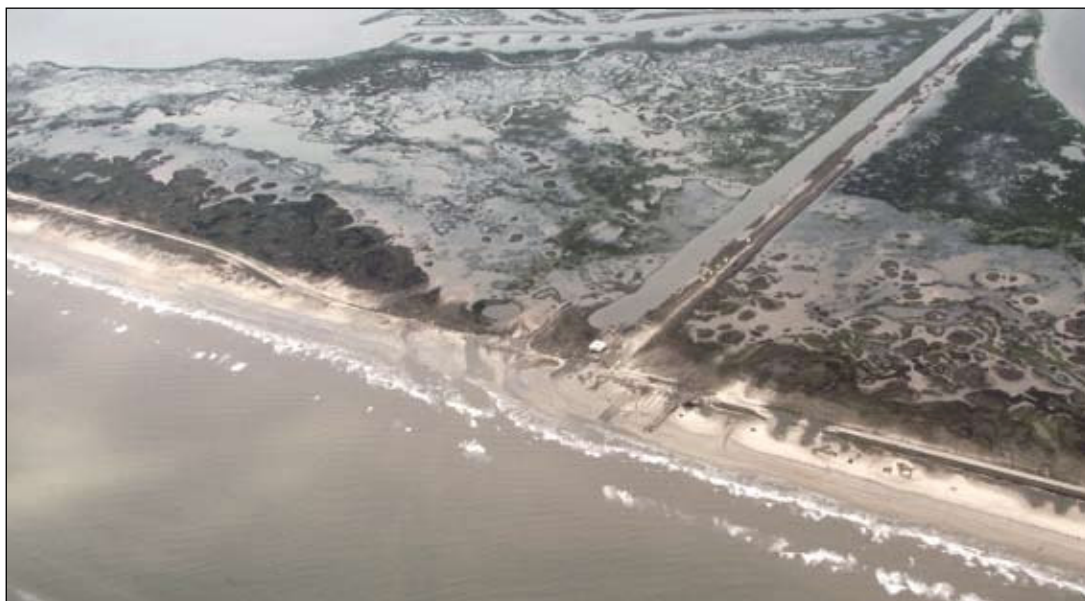
Follets Island, just southwest of Galveston Island, is a narrow barrier island. The only road running along its length approaches the beach in several locations, and it is unprotected by any significant dune ridges or man-made structures. Ike breached the road in many locations and left homes on the beach, with some standing in the remains of hurricane outwash channels (Figures 15 and 16).

Figure 15. The only road running the length of Follets Island was cut here and in many other locations. Most channels across the beach were probably excavated by outwash of the surge flood. Photograph by the author, taken 15 September 2008.

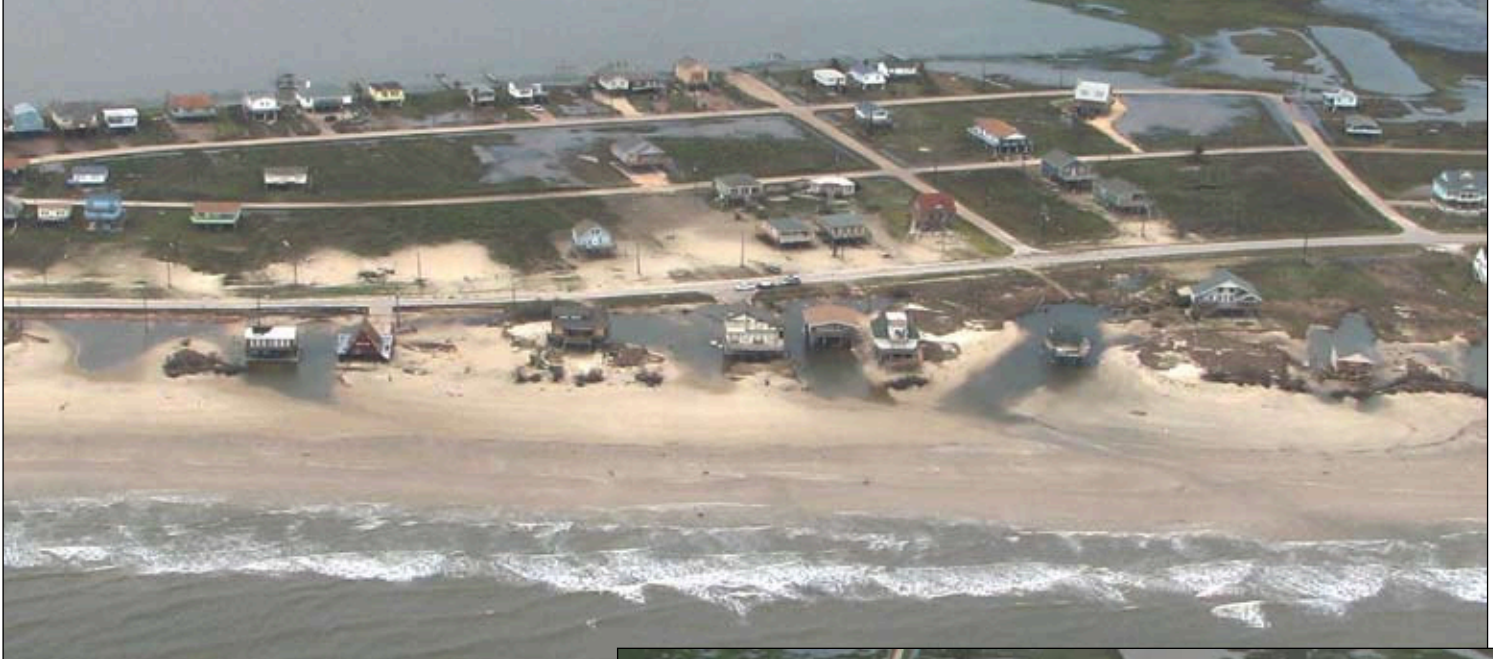
Figure 16. Follets Island homes standing on the beach and in hurricane outwash channels. Photograph by the author, taken 15 September 2008.

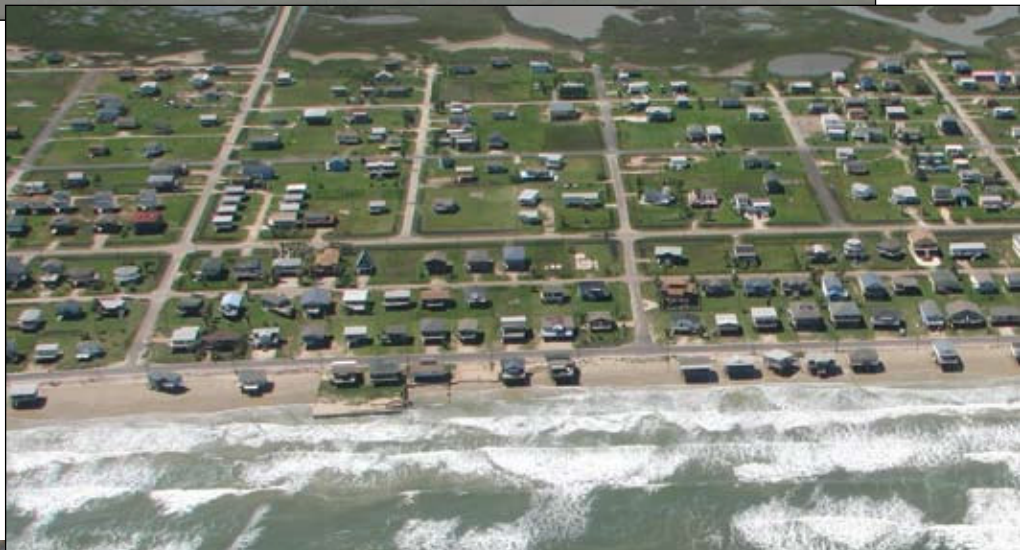
Surfside Village, located just northeast of the Freeport Entrance Channel, experienced severe beach erosion for many years. Even before Hurricane Ike, there were houses standing on the beach (Figure 17). Just weeks before Ike came ashore, the Texas General Land Office (TGLO) completed a low granite revetment landward of the homes shown in Figure 18 and along the very edge of Beach Drive, the road along the beach. Even though Ike removed nearly all of the remaining homes on the beach, the revetment protected Beach Drive from serious damage and probably helped protect the homes on the landward side of the road (Figure 18).

In 1928, the mouth of the Brazos River was moved from the Freeport Entrance Channel at Surfside 7 miles to the west. Relocation of the river mouth removed its sediment supply at Surfside and caused erosion of the old delta and the beaches at Surfside (Watson 2003).

Figure 17. Long-term erosion and shoreline recession have left many homes on the beach at Surfside Village even before Hurricane Ike. Another row of homes seaward of these was lost in recent years. Photograph by the author, taken 26 April 2007.

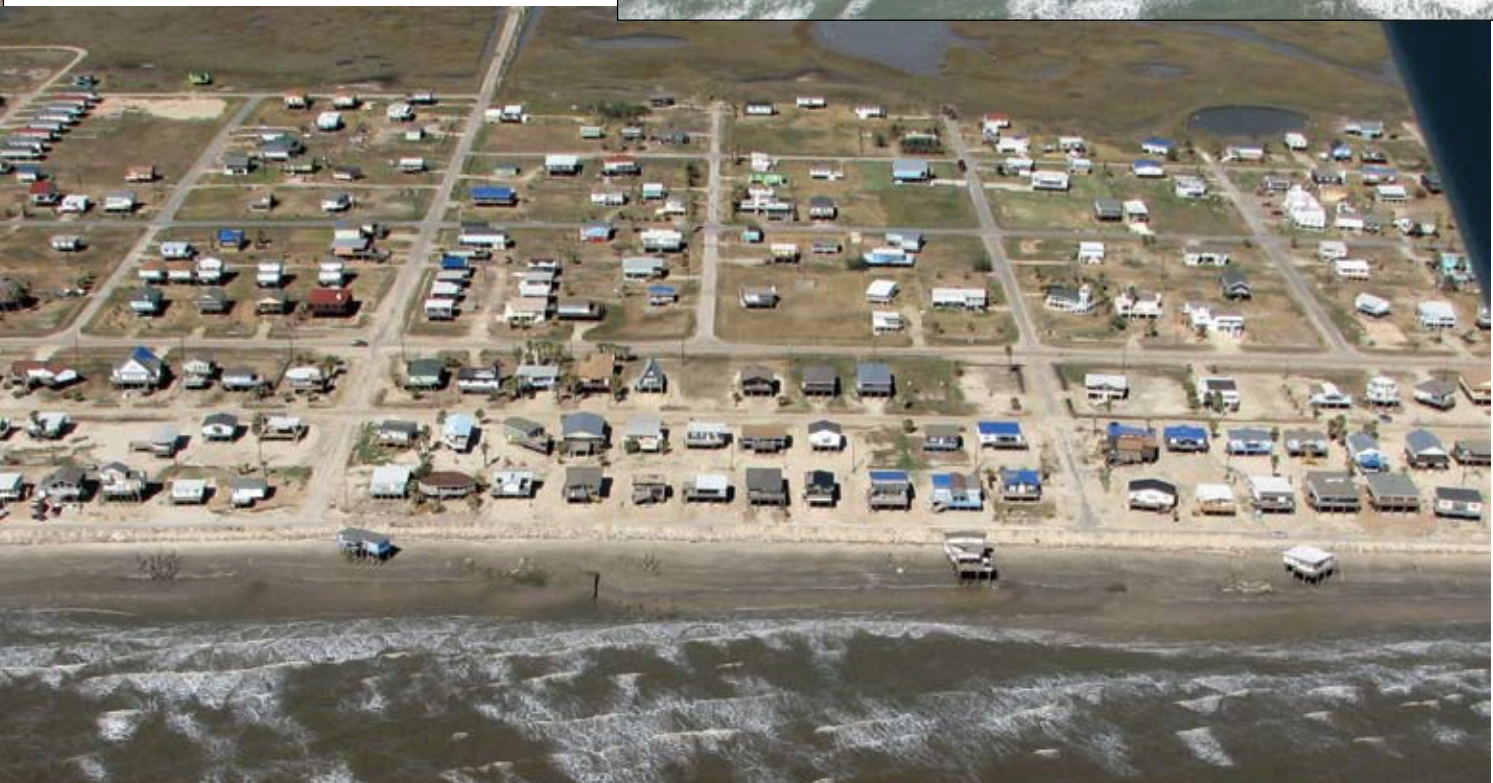
Figure 18. Surfside Village after Hurricane Ike. Most of the homes that were on the beach were destroyed. Photograph by the author, taken 28 October 2008.
