# *Shoaling Analysis Leggett Light Channel*

**April, 1999**

**For  
Aransas County Navigation District No. 1  
Rockport, Texas**

Richard L. Watson, Ph.D.  
Consulting Geologist  
P.O. Box 1040  
Port Aransas, Tx 78373  
(361) 749-4152

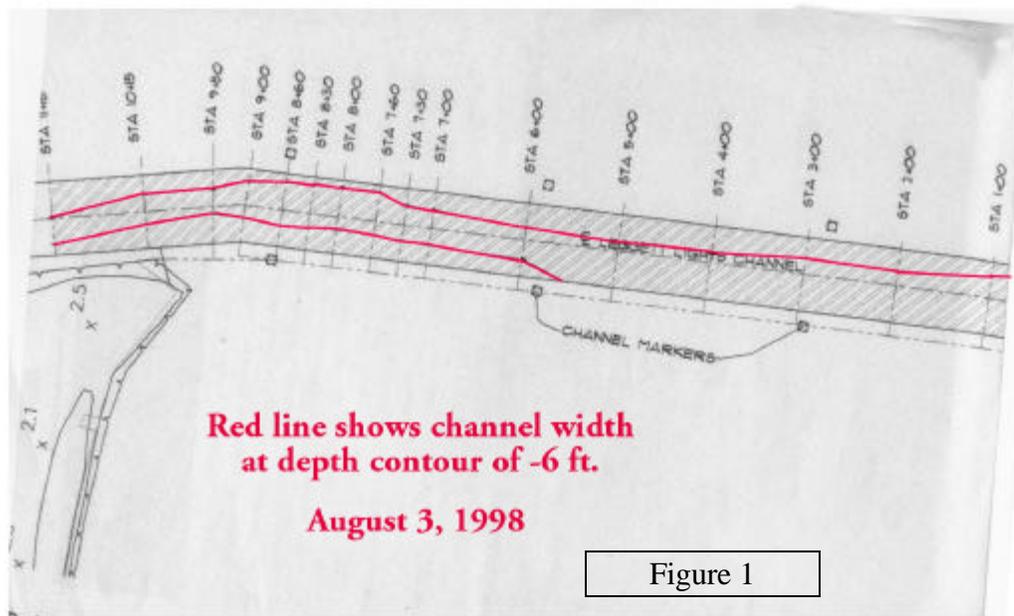
Figure 1

There are three distinct shoaling areas with different processes causing shoaling in each area. A plot of the -6 ft. depth contour determined from the profiles in the 1998 Brundrett survey shows the location of the shoaling areas (Fig. 1). Note: there is major shoaling of

the outer part of the east side of the channel from station 2+00 through station 7+30. We will call this the outer east side. The second area of major shoaling is on the east side of the channel from station 9+00 to station 11+15. We will call this the inner east side. There is very little shoaling on the east side from station 7+30 to station 9+00. Finally, there is significant shoaling of the channel on the west side from station 6+00 to station 10+15. We will call this area the west side. Figure 2 is a plot of the -6ft. depth contour taken from the profiles measured in the 1992-1993 Brundrett survey. It shows a similar shoaling pattern to the 1998 survey.

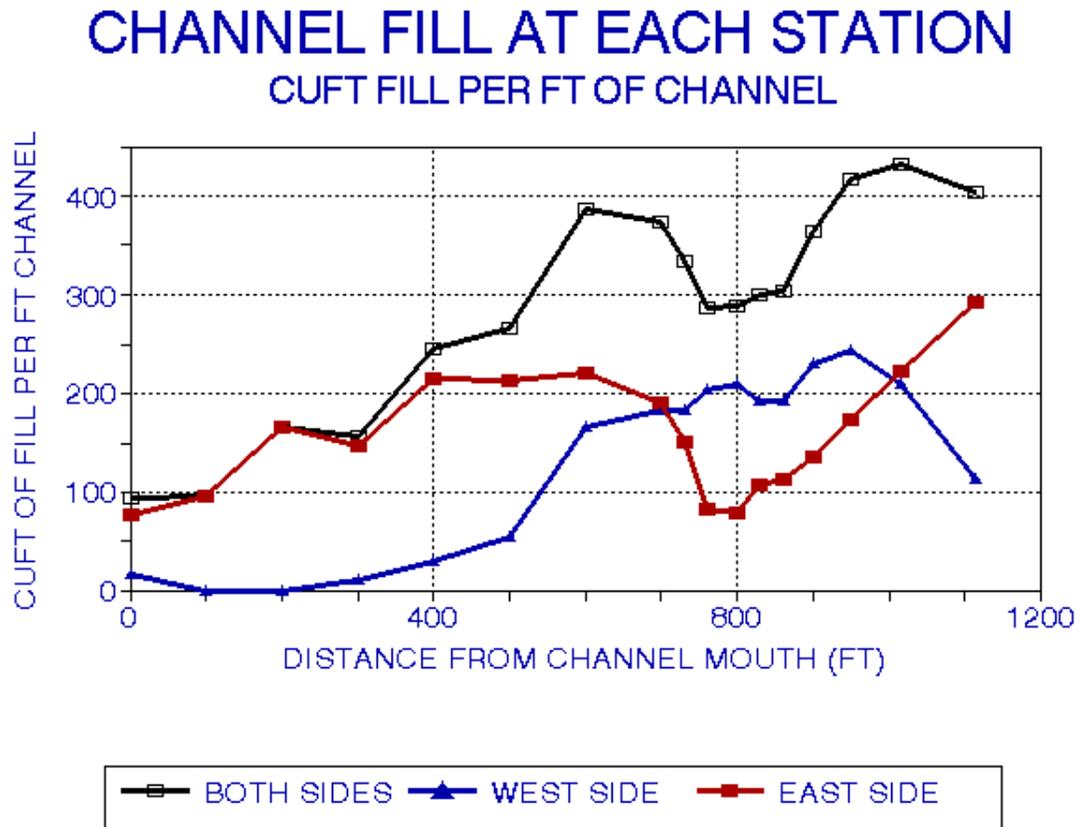
Figure 3

The channel fill rate at each station along the channel is presented graphically in Figure 3. This clearly shows the three different areas of concern. The red line shows the rate of shoaling is high on the outer east side from 200 ft. to 700 ft. from the channel mouth, drops low from 700 to 900 ft. on the middle east side, and rises sharply from 900 ft. to 1100 ft. on the inner east side. The blue line representing the west side of the channel shows the shoaling starts near 600 ft. from the channel entrance and stays high until over 1000 ft. from the channel entrance. The black line is a plot of a total of both sides of the channel. It shows the total shoaling, and thus the greatest navigation hazard exists, from 500 ft to 700 ft. and from 900 ft. to 1100 ft. The problem is reduced from 700 ft. to 900 feet due to the reduction in shoaling on the east side. The total shoaling is also not as serious between 500 ft and the entrance, because there is no shoaling on the west side in the outer channel.

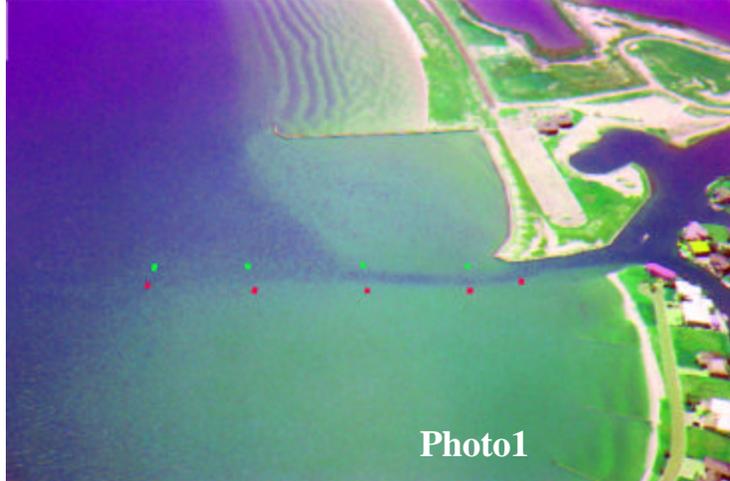
Photo 1

Some enhanced aerial photographs will enable us to get a better understanding of the shoaling areas. A large shallow shoal exists on the east side of the Leggett Light Channel out to within 100 feet of the outer channel marker and covers the entire area to the east toward nine mile point. The shoal on the west side of the channel extends from the concrete bag groin at the east end of Rockport beach to the Leggett Light Channel (Photo 1). Note the shoal west of the channel has

been truncated almost in a straight line from the end of the groin to the channel at the third channel marker from the entrance. There is no truncation of the shoal on the east side of the Leggett Light Channel. Photo 2 also clearly shows how the shoal is truncated on the west side of the channel. Note also how far the shoaling on the east side of the channel has progressed into the channel past the location of the channel markers.

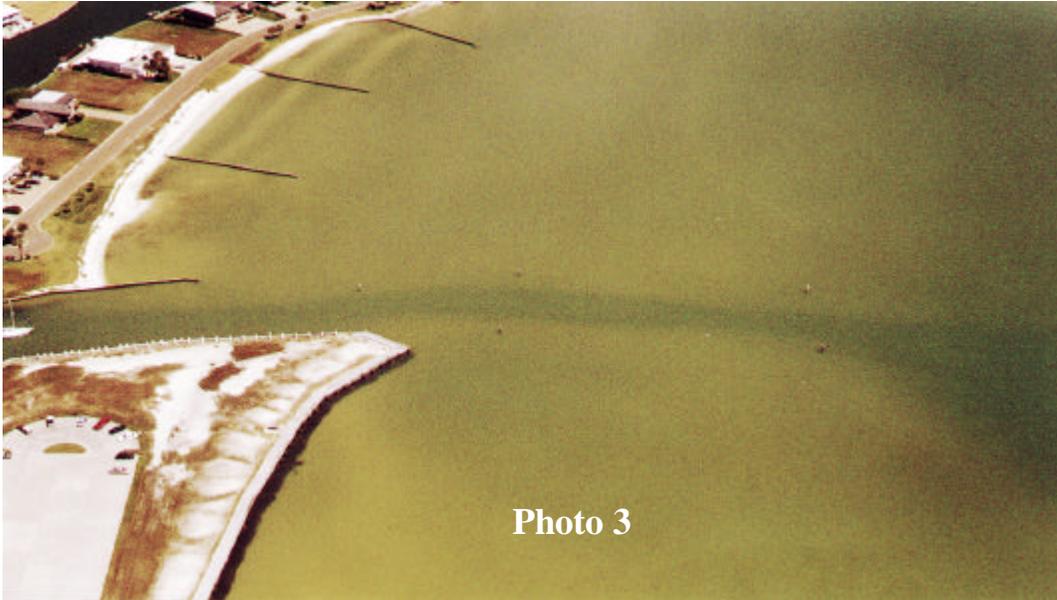
Photo 3

Photo three also shows how far the sand has moved into the channel relative to the channel markers. There is a narrow choke point just inside of the markers near station 6+00.

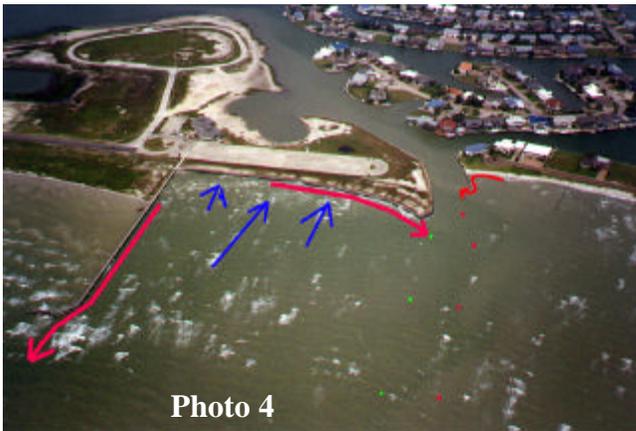
Most of the sediment movement on Rockport Beach and on the shoals adjacent to Leggett Light Channel is due to water motions from wind generated waves. The winds affecting this shoreline are predominantly from the east to the southeast (Fig.4). This means most of the wave generated sediment transport will be toward the west. This readily explains the sediment transport into the channel from the shoal east of the channel. However, there is also a large amount of sediment being transported into the channel on the west side. There are many days when the wind is from the south or nearly from the south. This south wind, in conjunction with the position of the groin at the east end of the beach, has aided in the shoaling process on the west side of the channel. Photo 4 shows how this is happening. On April 9<sup>th</sup>, when

the groin, it must return to the bay. There is a return flow seaward along the groin shown by the red arrow and also a return flow along the seawall into the channel. This is the reason for the large amount of shoaling on the west side of the channel near the seawall. This is probably also occurring during southeast winds. The outer part of the west side shoal between the Leggett Light Channel and the groin on the east part of the beach has been truncated by erosion. Most of this material has probably been carried into the channel over the years. The net sediment transport along this shoreline is to the west. No sediment can pass from the east side of the channel to the west side, so the shoal between the channel and the groin on the east end of the beach is slowly being eroded and deposited into the channel. If the groin had been built along the west side of the channel, where it could also serve as a jetty for the channel, there would have been no deposition of sand on the west side of the channel. In the present configuration, the shoal between the east beach groin and the channel will continue to erode into the west side of the channel.

Note: even with the wind nearly out of the south, there is also a return flow along the east seawall and around the east jetty into the channel. This is the major source of the shoaling

this photo was taken, the wind was from 160 to 176 degrees at 17 to 23 knots. Once the waves break, they are actually transporting water in the directions shown by the blue arrows. If water is moving onshore in the area constrained by the seawall and

on the inner east side. The outer part of the big shoal east of the channel has not been truncated by erosion into the channel, because it is continually re-supplied with sand moving along it from the huge shoal to the east.

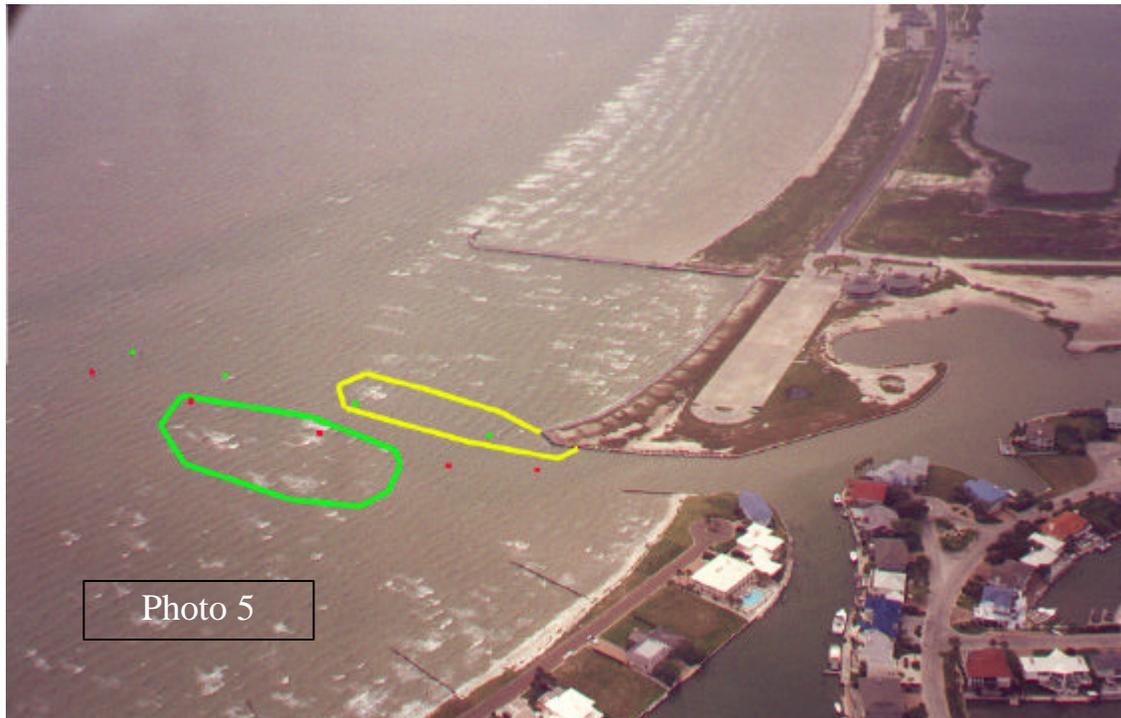
Photo 5 shows the shoals breaking under the influence of waves generated by south winds of 17 to 23 knots on April 9, 1999. The west side shoaling area is circled in yellow. The waves breaking on the outer part of this shoal will transport sand directly into the channel. The inner part of the yellow area is transporting sand into the channel with the aid of the return currents moving to the east along the seawall. The green circled area is the outer east side shoaling area. The surf breaking on the shoal adjacent to the channel has a net movement toward the channel and will continue to fill the channel. Note that there is no surf breaking in the inner east side near the inner two red channel markers. This is the area where little sand is entering the east side of the channel. Most of the wave energy has been expended further out in the green circled area. Surf again reappears near the beach in very shallow water. Under the normal southeast wind, these waves are approaching the beach on the east side of the channel with a component directed toward the west. These breaking waves create a current in the surf along the beach which moves to the west, around the small jetty on the east side of the channel and provide the sand which is shoaling the inner east side of the channel (see Photo 4).
