Shoaling Analysis Leggett Light Channel

April, 1999

**For
Aransas County Navigation District No. 1
Rockport, Texas**

Richard L. Watson, Ph.D.
Consulting Geologist
P.O. Box 1040
Port Aransas, Tx 78373
(361) 749-4152

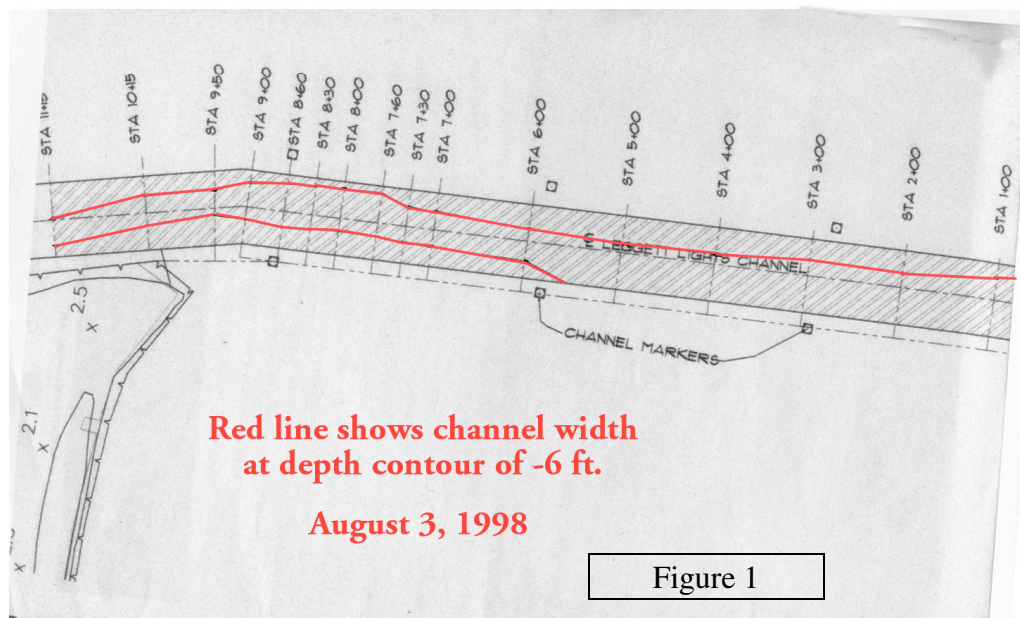
There are three distinct shoaling areas with different processes causing shoaling in each area. A plot of the -6 ft. depth contour determined from the profiles in the 1998 Brundrett survey shows the location of the shoaling areas (Fig. 1). Note: there is major shoaling of

the outer part of the east side of the channel from station 2+00 through station 7+30. We will call this the outer east side. The second area of major shoaling is on the east side of the channel from station 9+00 to station 11+15. We will call this the inner east side. There is very little shoaling on the east side from station 7+30 to station 9+00. Finally, there is significant shoaling of the channel on the west side from station 6+00 to station 10+15. We will call this area the west side. Figure 2 is a plot of the -6ft. depth contour taken from the profiles measured in the 1992-1993 Brundrett survey. It shows a similar shoaling pattern to the 1998 survey.

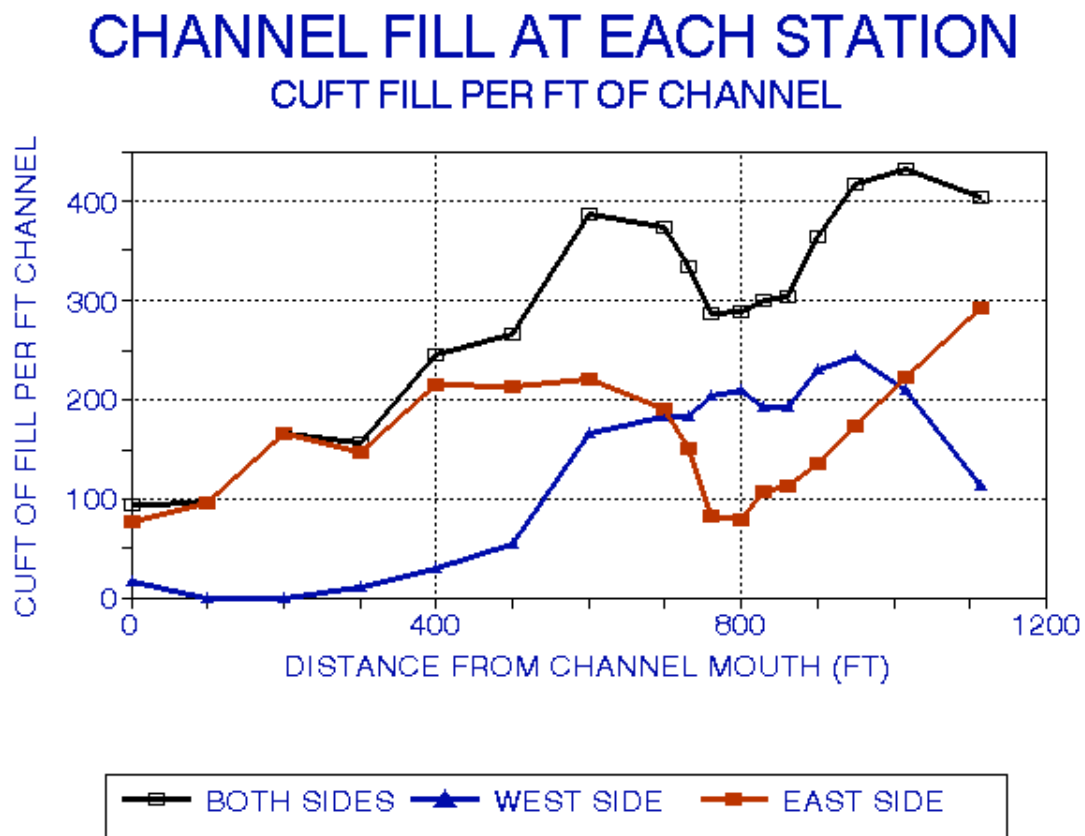
Figure 3

The channel fill rate at each station along the channel is presented graphically in Figure 3. This clearly shows the three different areas of concern. The red line shows the rate of shoaling is high on the outer east side from 200 ft. to 700 ft. from the channel mouth, drops low from 700 to 900 ft. on the middle east side, and rises sharply from 900 ft. to 1100 ft. on the inner east side. The blue line representing the west side of the channel shows the shoaling starts near 600 ft. from the channel entrance and stays high until over 1000 ft. from the channel entrance. The black line is a plot of a total of both sides of the channel. It shows the total shoaling, and thus the greatest navigation hazard exists, from 500 ft to 700 ft. and from 900 ft. to 1100 ft. The problem is reduced from 700 ft. to 900 feet due to the reduction in shoaling on the east side. The total shoaling is also not as serious between 500 ft and the entrance, because there is no shoaling on the west side in the outer channel.

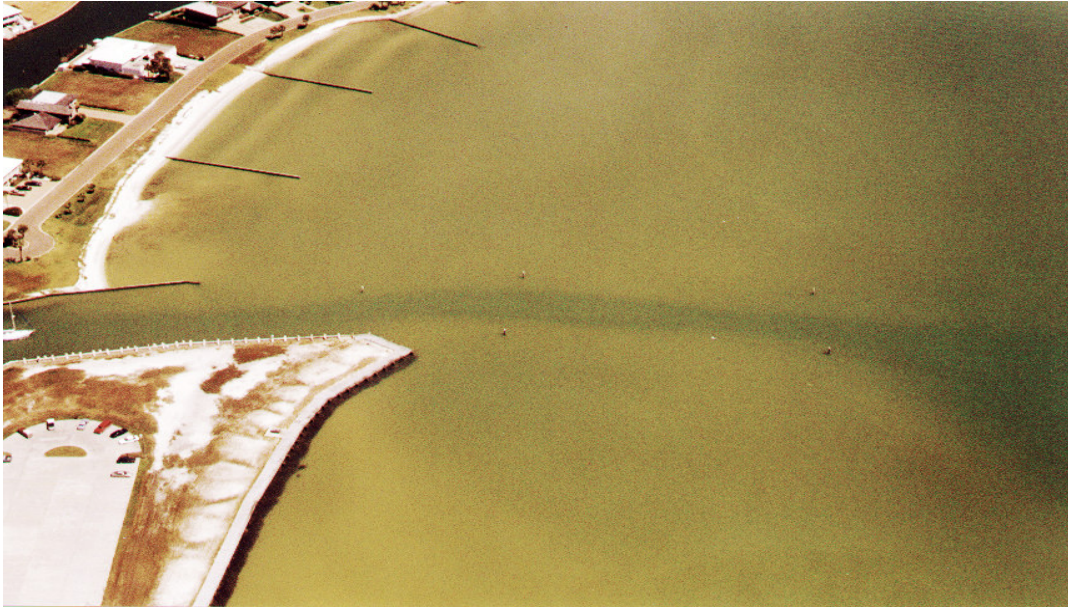
Some enhanced aerial photographs will enable us to get a better understanding of the shoaling areas. A large shallow shoal exists on the east side of the Leggett Light Channel out to within 100 feet of the outer channel marker and covers the entire area to the east toward nine mile point. The shoal on the west side of the channel extends from the concrete bag groin at the east end of Rockport beach to the Leggett Light Channel (Photo 1). Note the shoal west of the channel has been truncated almost in a straight line from the end of the groin to the channel at the third channel marker from the entrance. There is no truncation of the shoal on the east side of the Leggett Light Channel. Photo 2 also clearly shows how the shoal is truncated on the west side of the channel. Note also how far the shoaling on the east side of the channel has progressed into the channel past the location of the channel

markers.

Photo three also shows how far the sand has moved into the channel relative to the channel markers. There is a narrow choke point just inside of the markers near station 6+00.

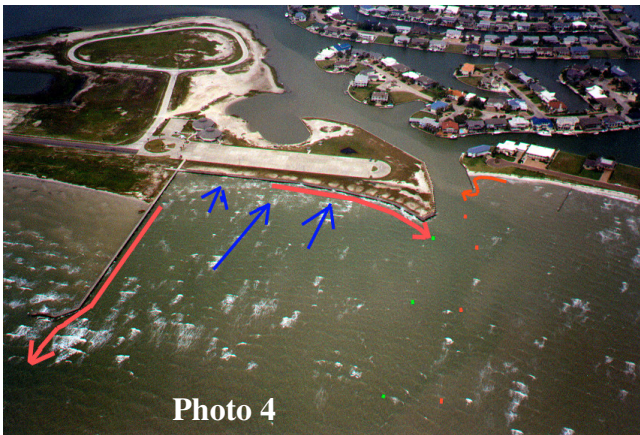
Most of the sediment movement on Rockport Beach and on the shoals adjacent to Leggett Light Channel is due to water motions from wind generated waves. The winds affecting this shoreline are predominantly from the east to the southeast (Fig.4). This means most of the wave generated sediment transport will be toward the west. This readily explains the sediment transport into the channel from the shoal east of the channel. However, there is also a large amount of sediment being transported into the channel on the west side. There are many days when the wind is from the south or nearly from the south. This south wind, in conjunction with the position of the groin at the east end of the beach, has aided in the shoaling process on the west side of the channel. Photo 4 shows how this is happening. On April 9th, when

the groin, it must return to the bay. There is a return flow seaward along the groin shown by the red arrow and also a return flow along the seawall into the channel. This is the reason for the large amount of shoaling on the west side of the channel near the seawall. This is probably also occurring during southeast winds. The outer part of the west side shoal between the Leggett Light Channel and the groin on the east part of the beach has been truncated by erosion. Most of this material has probably been carried into the channel over the years. The net sediment transport along this shoreline is to the west. No sediment can pass from the east side of the channel to the west side, so the shoal between the channel and the groin on the east end of the beach is slowly being eroded and deposited into the channel. If the groin had been built along the west side of the channel, where it could also serve as a jetty for the channel, there would have been no deposition of sand on the west side of the channel. In the present configuration, the shoal between the east beach groin and the channel will continue to erode into the west side of the channel.

Note: even with the wind nearly out of the south, there is also a return flow along the east

this photo was taken, the wind was from 160 to 176 degrees at 17 to 23 knots. Once the waves break, they are actually transporting water in the directions shown by the blue arrows. If water is moving onshore in the area constrained by the seawall and

seawall and around the east jetty into the channel. This is the major source of the shoaling on the inner east side. The outer part of the big shoal east of the channel has not been truncated by erosion into the channel, because it is continually re-supplied with sand moving along it from the huge shoal to the east.

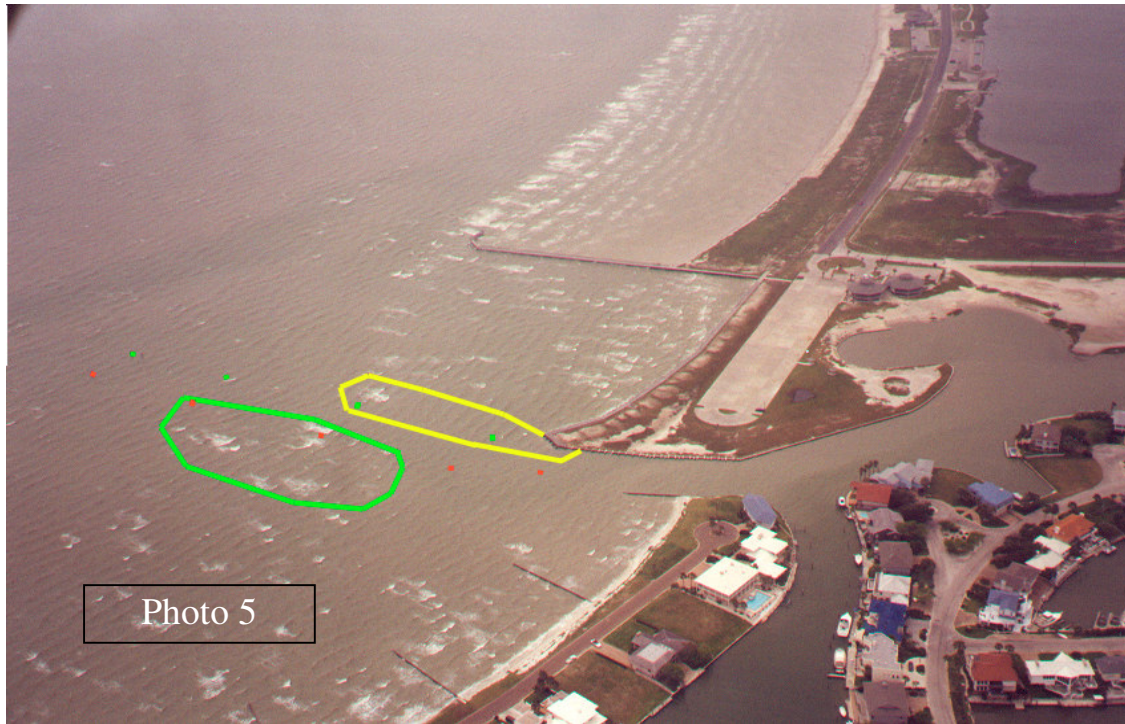
Photo 5 shows the shoals breaking under the influence of waves generated by south winds of 17 to 23 knots on April 9, 1999. The west side shoaling area is circled in yellow. The waves breaking on the outer part of this shoal will transport sand directly into the channel. The inner part of the yellow area is transporting sand into the channel with the aid of the return currents moving to the east along the seawall. The green circled area is the outer east side shoaling area. The surf breaking on the shoal adjacent to the channel has a net movement toward the channel and will continue to fill the channel. Note that there is no surf breaking in the inner east side near the inner two red channel markers. This is the area where little sand is entering the east side of the channel. Most of the wave energy has been expended further out in the green circled area. Surf again reappears near the beach in very shallow water. Under the normal southeast wind, these waves are approaching the beach on the east side of the channel with a component directed toward the west. These breaking waves create a current in the surf along the beach which moves to the west, around the small jetty on the east side of the channel and provide the sand which is shoaling the inner east side of the channel (see Photo 4).
