Evaluation of coastal response to Hurricane Ike through pre-storm and post-storm aerial photography

Richard L. Watson, Ph.D., P.G.

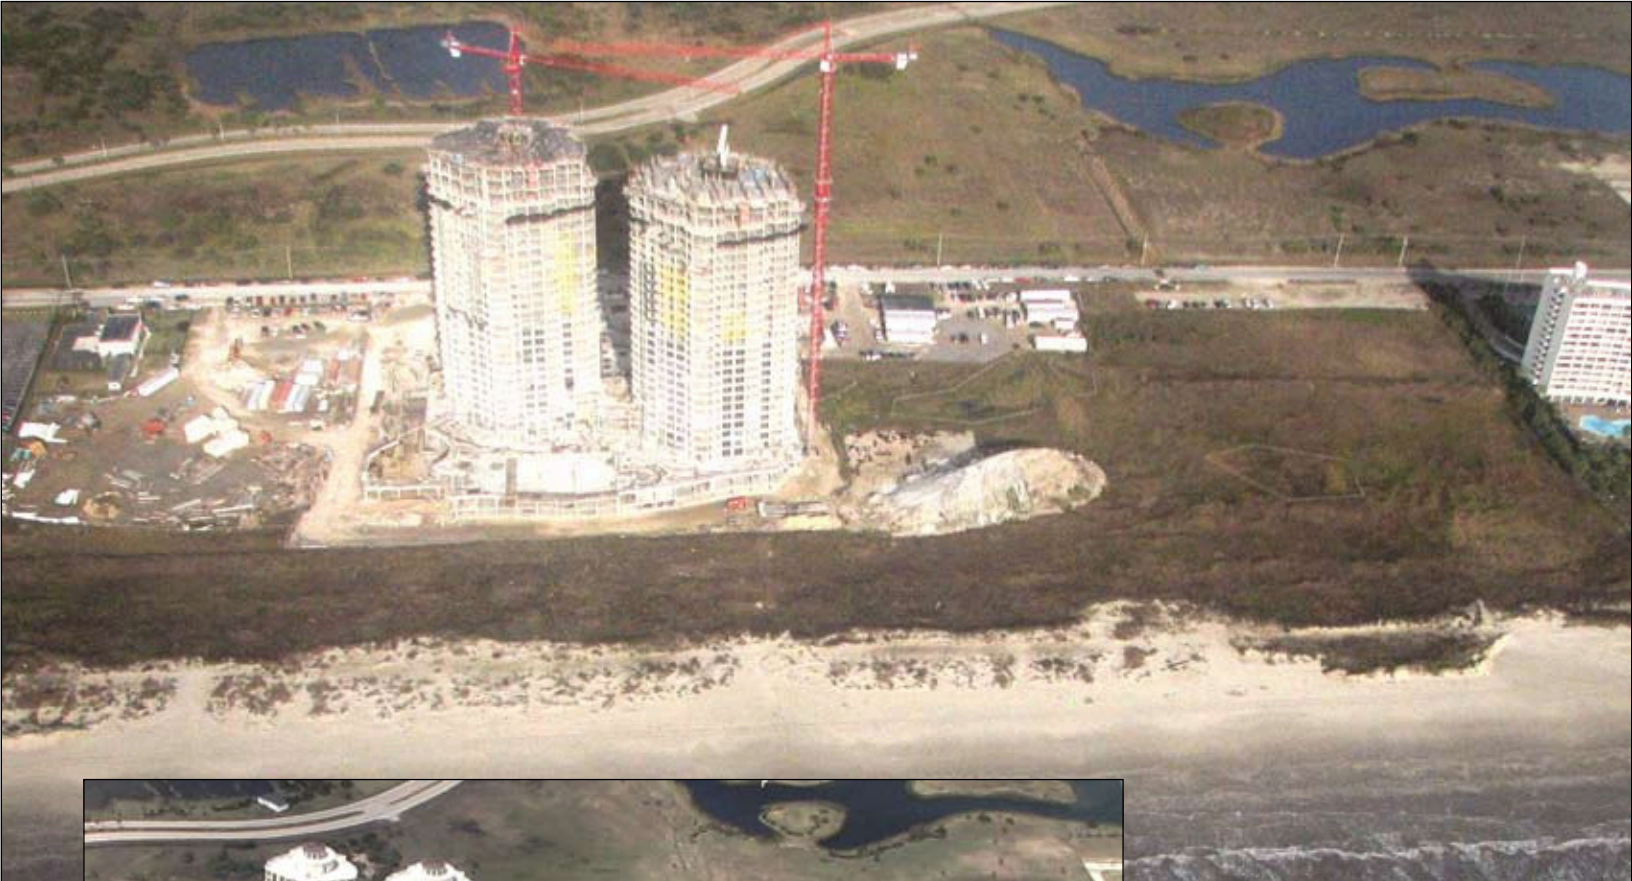
Galveston has new high-rise buildings and homes being built on vegetated flats behind the low dune line and seaward of the seawall on the east end of the island (Figure 10). Ike had little respect for the low dunes and washed up to, and under, the new buildings (Figure 11.) However, overwash was not nearly as severe as on the Bolivar Peninsula.

Figure 10. East Beach Galveston January 2007. Photograph by the author.
