Shoaling Analysis Leggett Light Channel

April, 1999

**For
Aransas County Navigation District No. 1
Rockport, Texas**

Richard L. Watson, Ph.D.
Consulting Geologist
P.O. Box 1040
Port Aransas, Tx 78373
(361) 749-4152

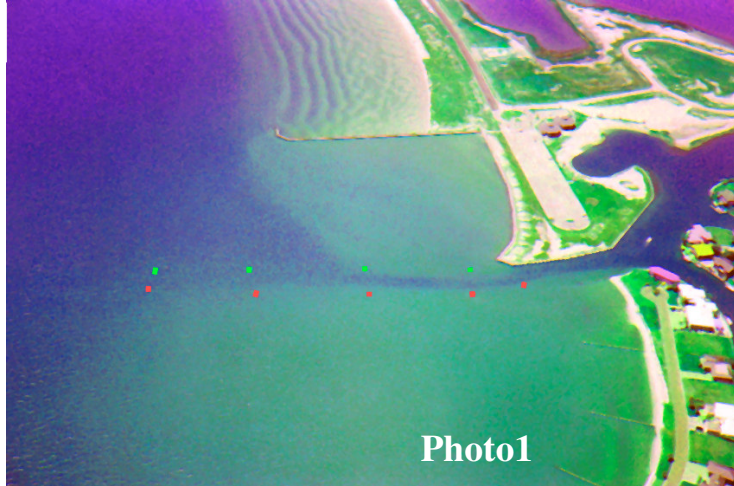
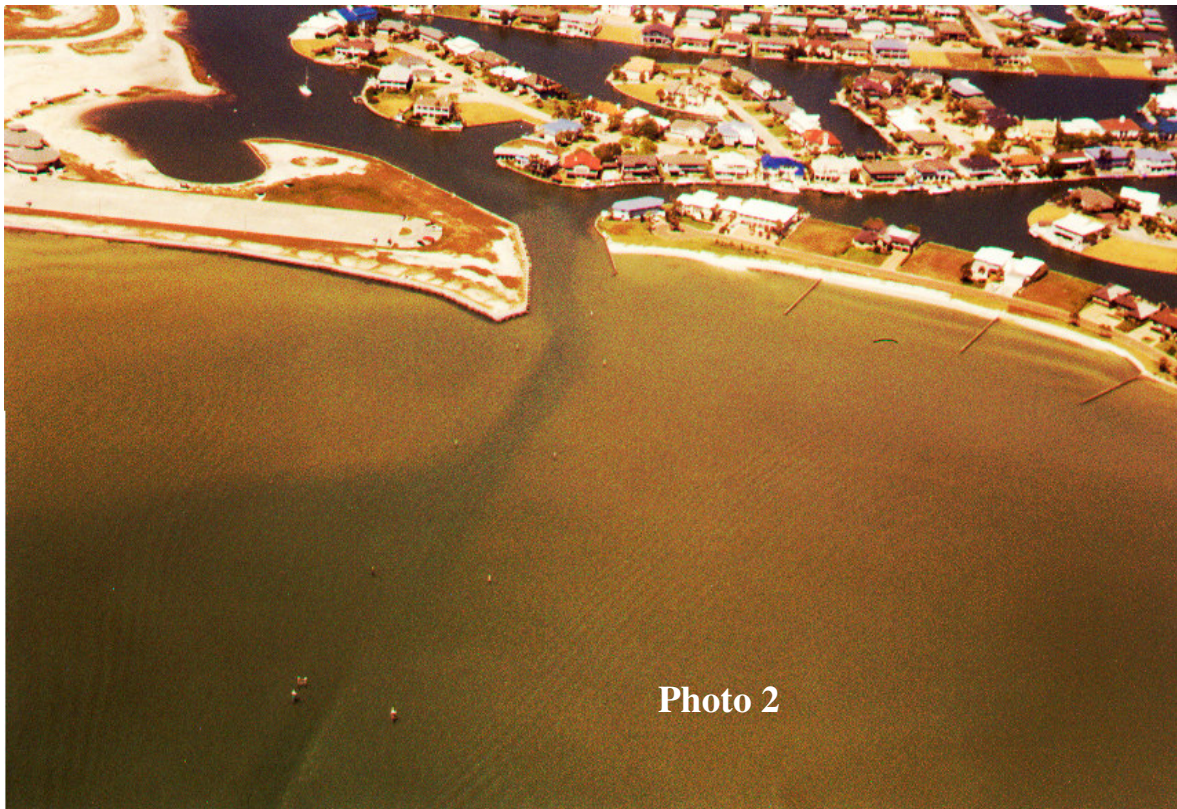
Some enhanced aerial photographs will enable us to get a better understanding of the shoaling areas. A large shallow shoal exists on the east side of the Leggett Light Channel out to within 100 feet of the outer channel marker and covers the entire area to the east toward nine mile point. The shoal on the west side of the channel extends from the concrete bag groin at the east end of Rockport beach to the Leggett Light Channel (Photo 1). Note the shoal west of the channel has been truncated almost in a straight line from the end of the groin to the channel at the third channel marker from the entrance. There is no truncation of the shoal on the east side of the Leggett Light Channel. Photo 2 also clearly shows how the shoal is truncated on the west side of the channel. Note also how far the shoaling on the east side of the channel has progressed into the channel past the location of the channel

markers.

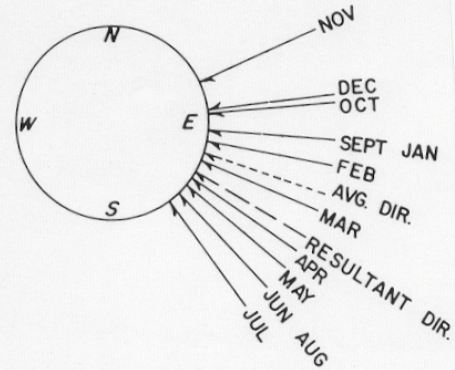
Figure 4, from (Watson, 1971)

Most of the sediment movement on Rockport Beach and on the shoals adjacent to Leggett Light Channel is due to water motions from wind generated waves. The winds affecting this shoreline are predominantly from the east to the southeast (Fig.4). This means most of the wave generated sediment transport will be toward the west. This readily explains the sediment transport into the channel from the shoal east of the channel. However, there is also a large amount of sediment being transported into the channel on the west side. There are many days when the wind is from the south or nearly from the south. This south wind, in conjunction with the position of the groin at the east end of the beach, has aided in the shoaling process on the west side of the channel. Photo 4 shows how this is happening. On April 9th, when
